# Contactor

*Information for electrical contractors, architects and consulting engineers*

## Transformer Slab Opening Area

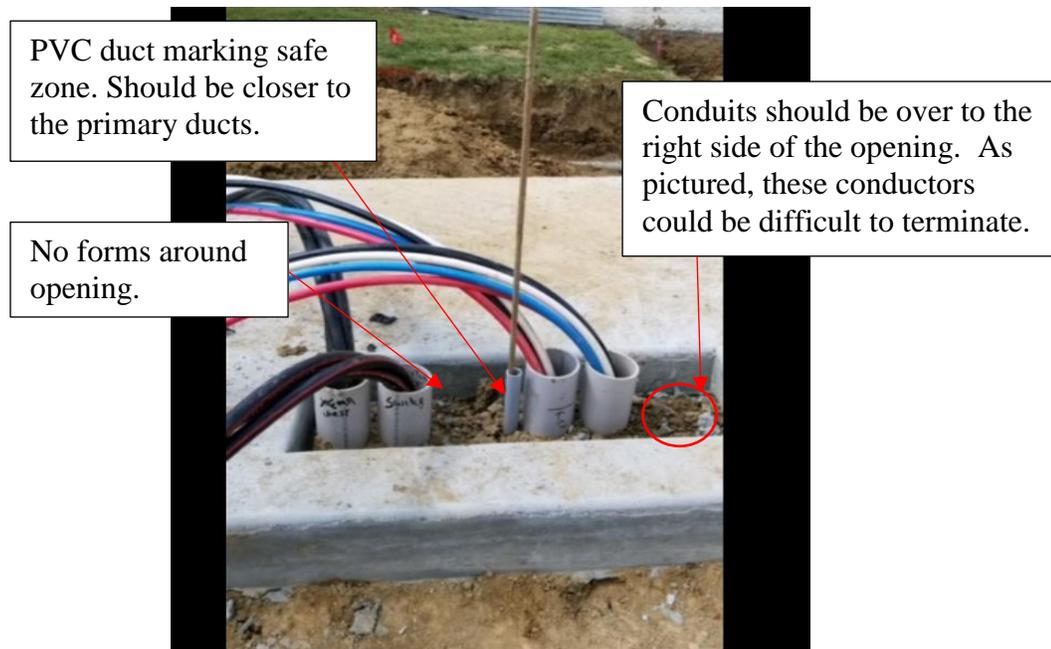
Additionally, the contractor should be removing slab forms once concrete is set. Failure to do so is pushing conduit towards the middle of the slab opening and outside the areas laid out in the slab drawings. Conduits should be installed as far to the right in the slab opening as possible as directed in the transformer slab drawings. That better enables the secondary conductors to be terminated.

Below is a picture to illustrate the instructions above. As noted, there are some things that should be different.

In an effort to avoid damaging conduit while installing a ground rod, OPPD is requiring the contractor to mark an area on the primary side of the transformer where installing the 8' ground rod will not run into any conduit installed below. It is suggested a small section of conduit identified as a ground location be placed in the ground showing the "safe zone". OPPD is not responsible for damage during ground rod installation if no marking is present. The safe zone should be approximately where the ground rod is shown on the slab details from the meter specification manual.
