CCR Landfill 2018 Annual Inspection Report

NC1 Ash Disposal Area

Omaha Public Power District
Nebraska City Station

Nebraska City, Nebraska
January 18, 2019

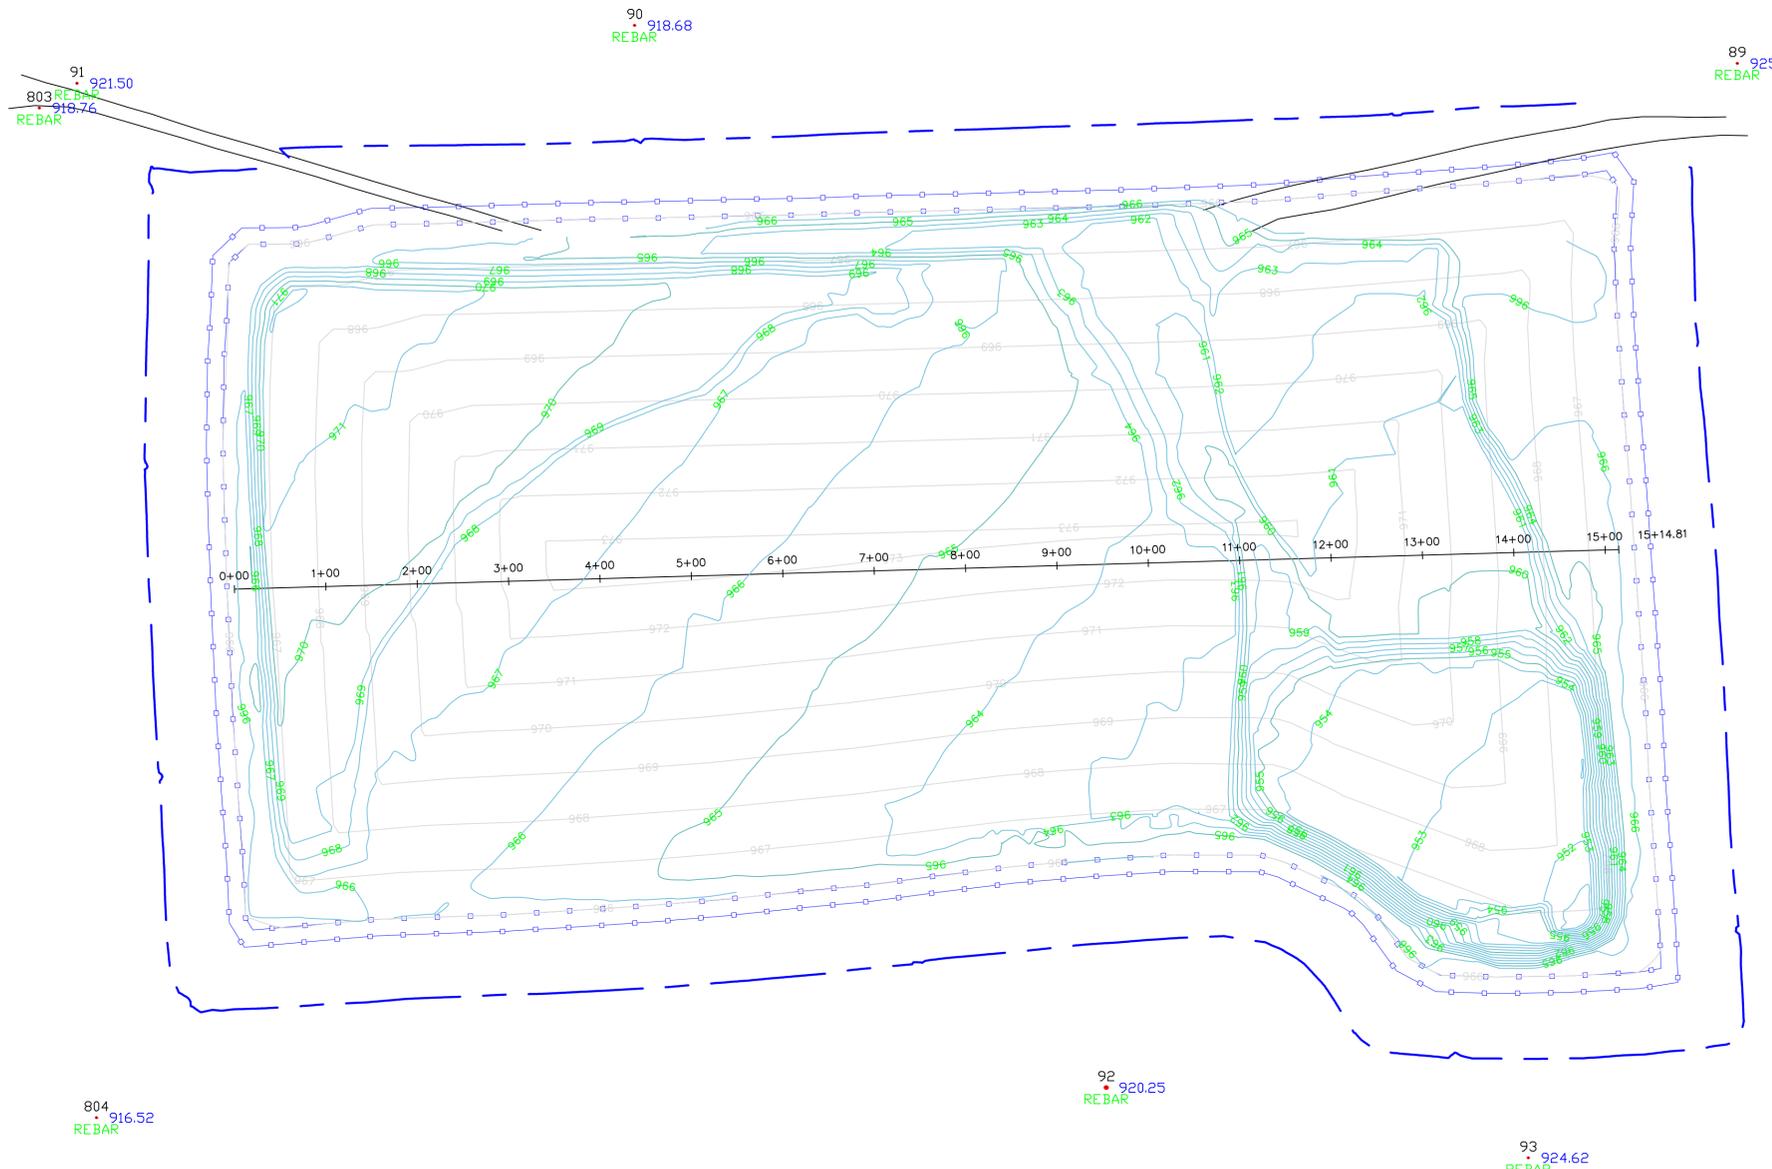
Appendix A
Facility Site Map

REMAINING AIRSPACE VOLUME AS OF 7-24-18
 Fill volume: 5,645,751.7 C.F., 209,101.91 C.Y.
 CUT/SWELL RATION 1:1

CUT VOLUME AS OF 7-24-18
 Cut volume: 304,007.4 C.F., 11,259.53 C.Y.

OVERALL SUMMARY AS OF 7-24-18
 Cut volume: 304,007.4 C.F., 11,259.53 C.Y.
 Fill volume: 5,645,751.7 C.F., 209,101.91 C.Y.

Area in Cut : 168,535.2 S.F., 3.87 Acres
 Area in Fill: 951,387.5 S.F., 21.84 Acres
 Total inclusion area: 1,119,922.7 S.F., 25.71 Acres

Average Cut Depth: 1.80 feet
 Average Fill Depth: 5.93 feet
 Cut to Fill ratio: 0.05
 Import Volume: 197,842.4 C.Y.
 Elevation Change To Reach Balance: -4.770
 Volume Change Per .1 ft: 4,147.9 C.Y.

A topographic survey was conducted on July 24, 2018. At the time of the of that survey top of CCR elevation ranged from approximately 951 to 972.

Total ash deposited within the NC1 Ash Disposal Area was estimated by comparing the July 2018 survey to the final permit grades and subtracting that volume from the projected total permit volume (3,300,000 cubic yards – 197,842.38 cubic yards = 3,102,157.62). Ash disposal estimates after the July 2018 survey through to the time of the inspection were estimated to be 80,000 cubic yards based the ash landfill records from that timeframe. The total CCR volume in place at the time of inspection is estimated to be 3,190,000 cubic yards.
