CCR Landfill 2020 Annual Inspection Report North Omaha Ash Landfill

Omaha Public Power District North Omaha Station

OPPD North Omaha Station NOS Ash Disposal Area CCR Landfill 2020 Annual Inspection Report

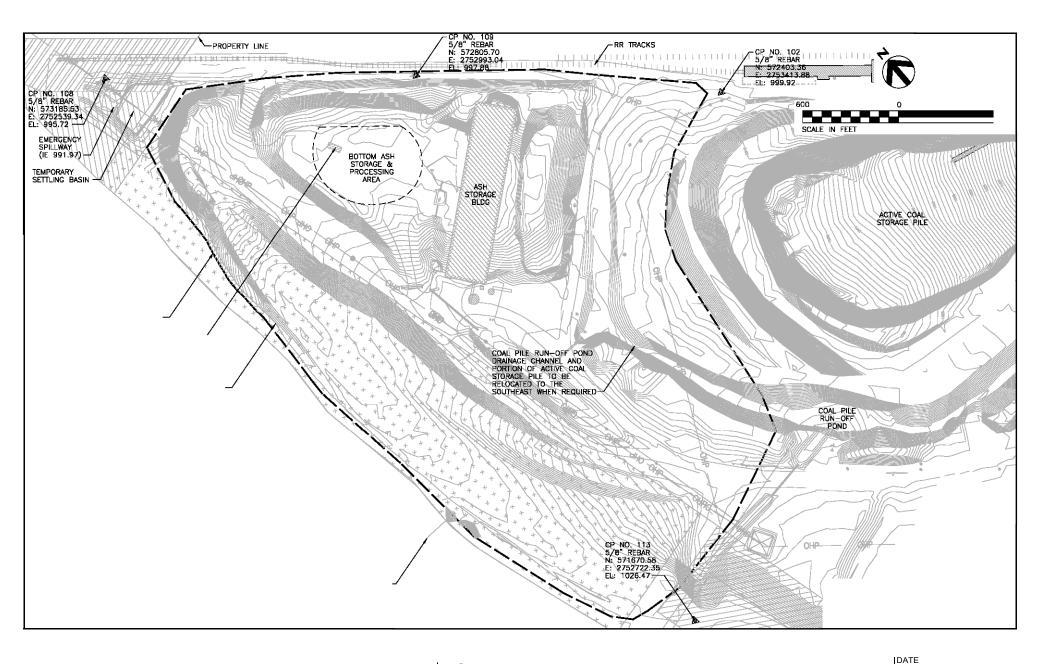
Appendix A Facility Site Map

OPPD NORTH OMAHA STATON NOS ASH DSPOSAL AREA

INSPECTION MAP

ash disposal area (NDEE Permit No. NE0054739, Facility ID 59763). The active, unlined CCR landfill is located on the north-northwest portion of the NOS property and encompasses approximately 18 acres. A facility site map is included in Appendix A.
